PRIMARY RECORD

Resource Identifier: Colfax Forest Fire Station

P10. Report Citations: (Provide full citation or enter "none") A Survey and Historic Significance Evaluation of the CDF
Building Inventory, 1994 Mark V. Thornton

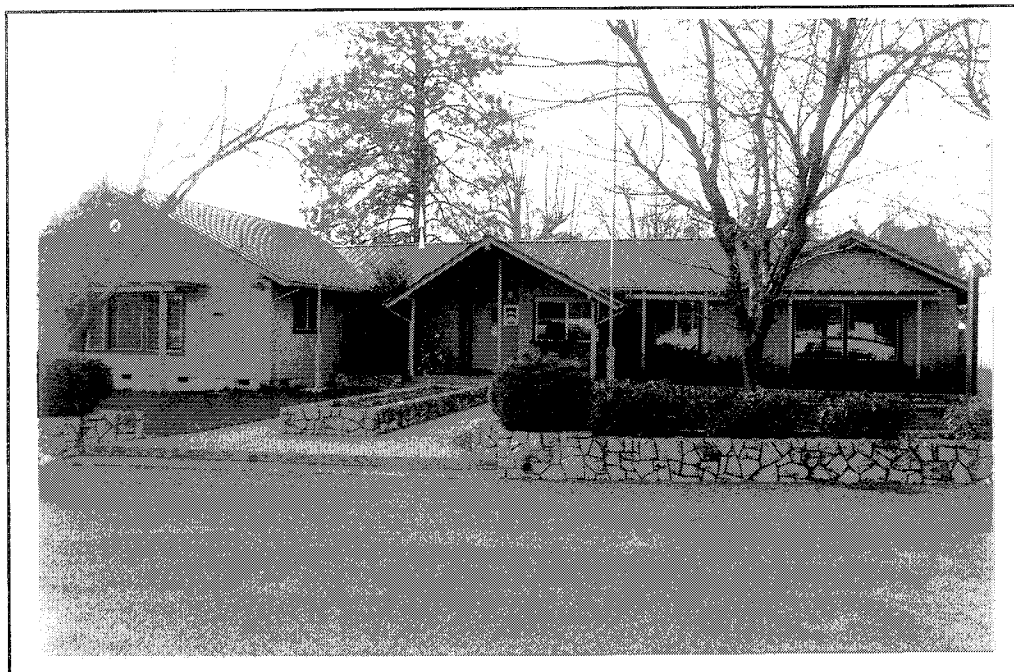
Front elevation of the administration office.

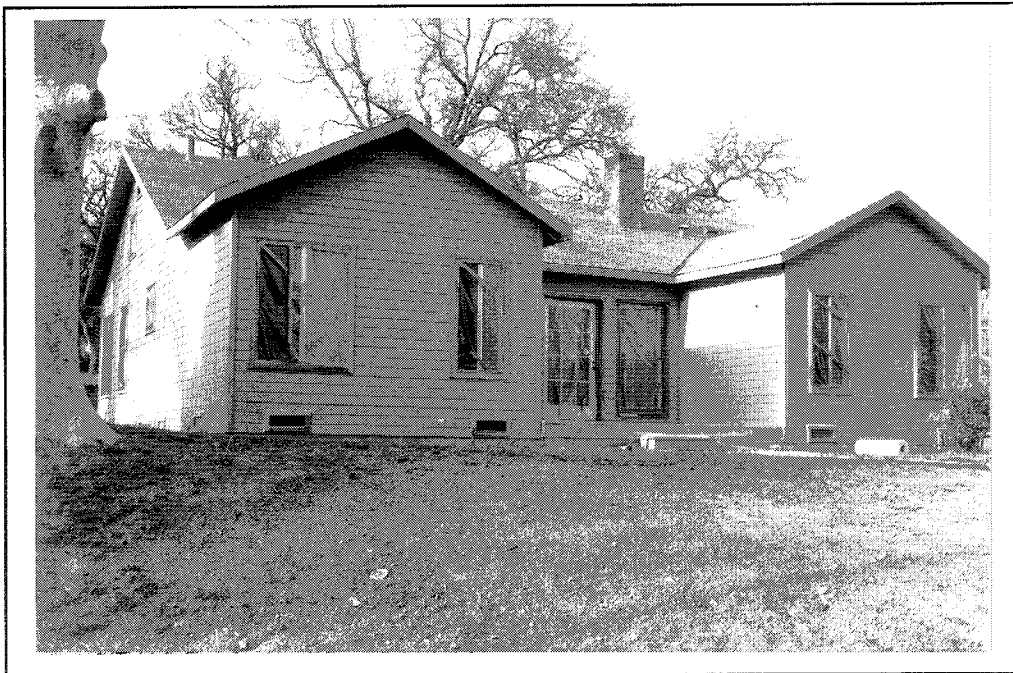
West and south elevations of the former ranger's residence.

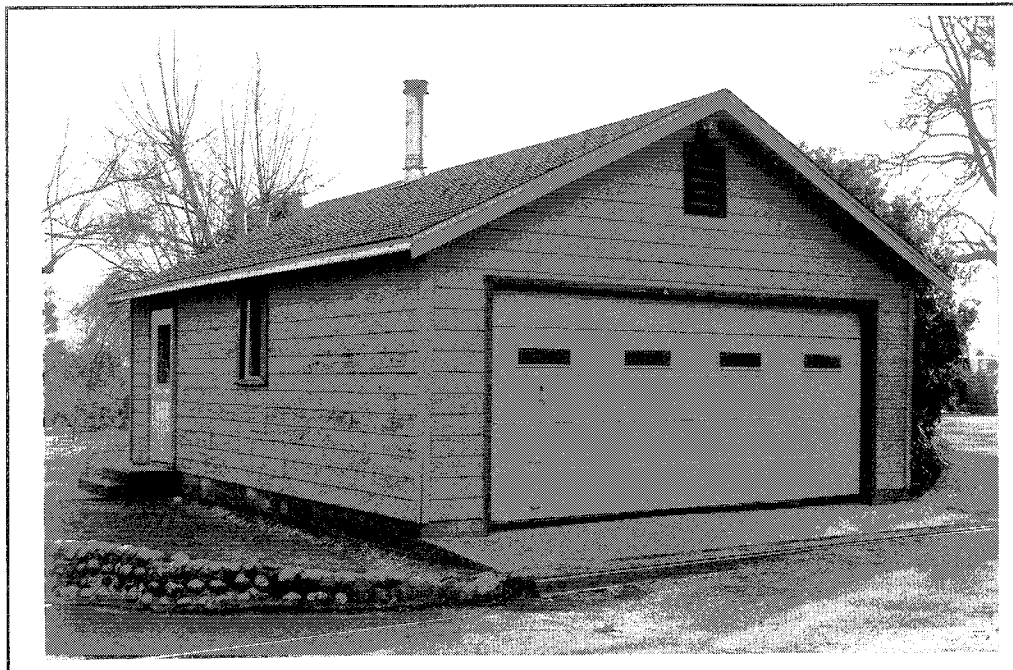
East and north elevations of the residence garage.

Two stall entry converted to one stall, windows replaced, 1970s (estimate).

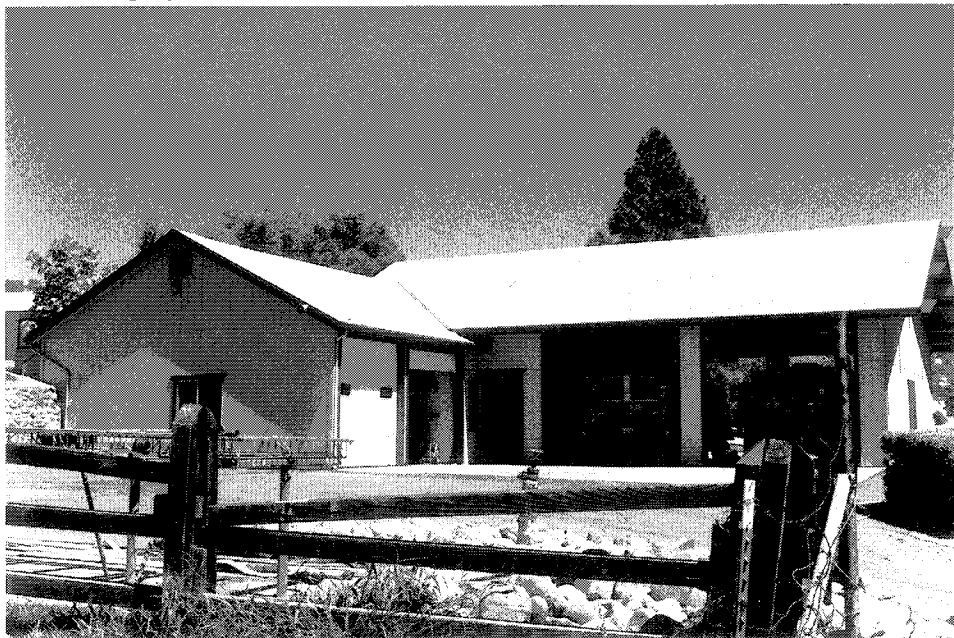
Southwest side of the combination office and four bay truck garage.

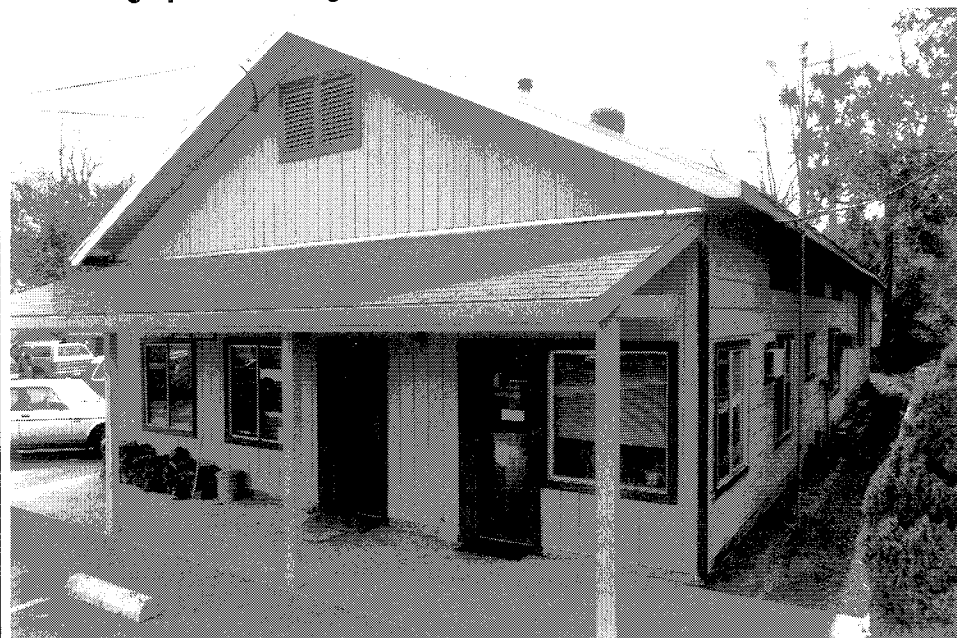
East and north elevations of the former warehouse (office).

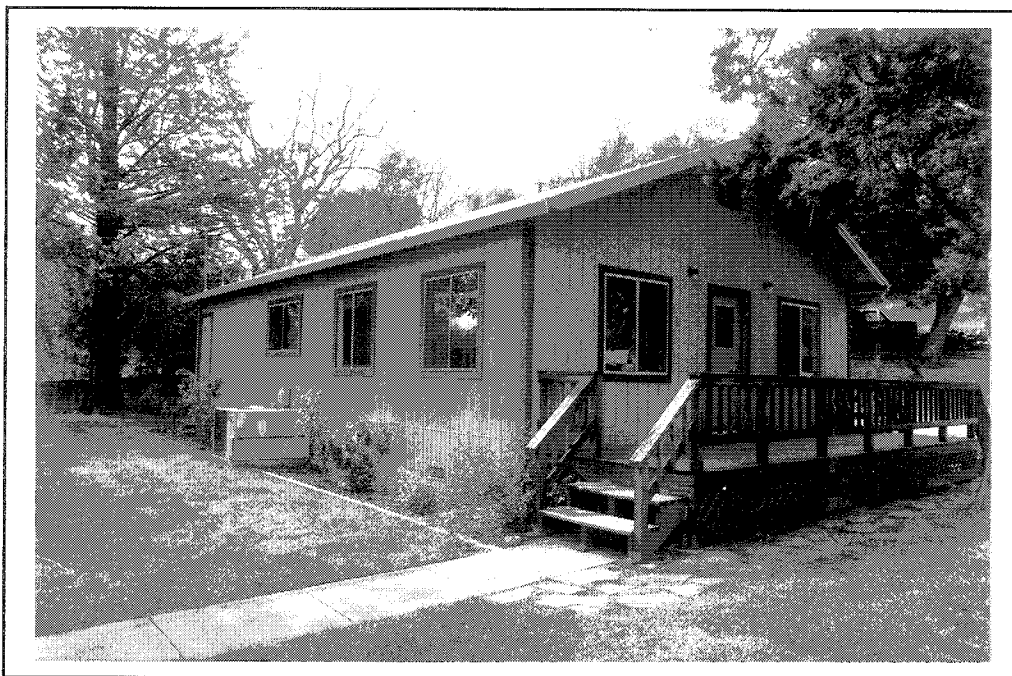
South and east elevations of the combination kitchen and messhall.

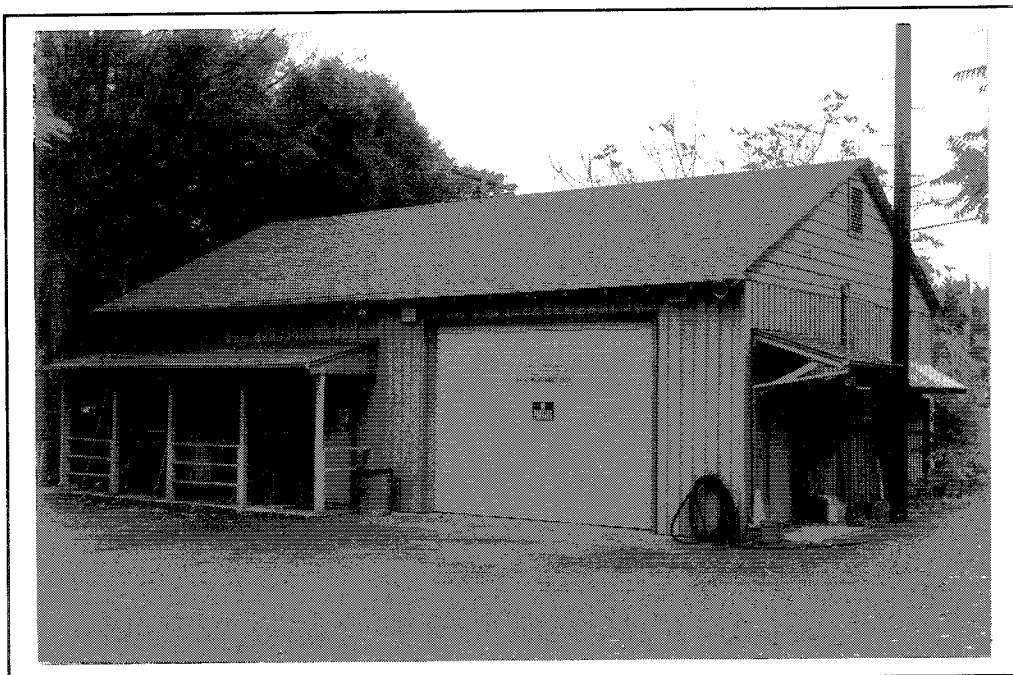
East and north elevations of the former garage (combination office and radio shop).

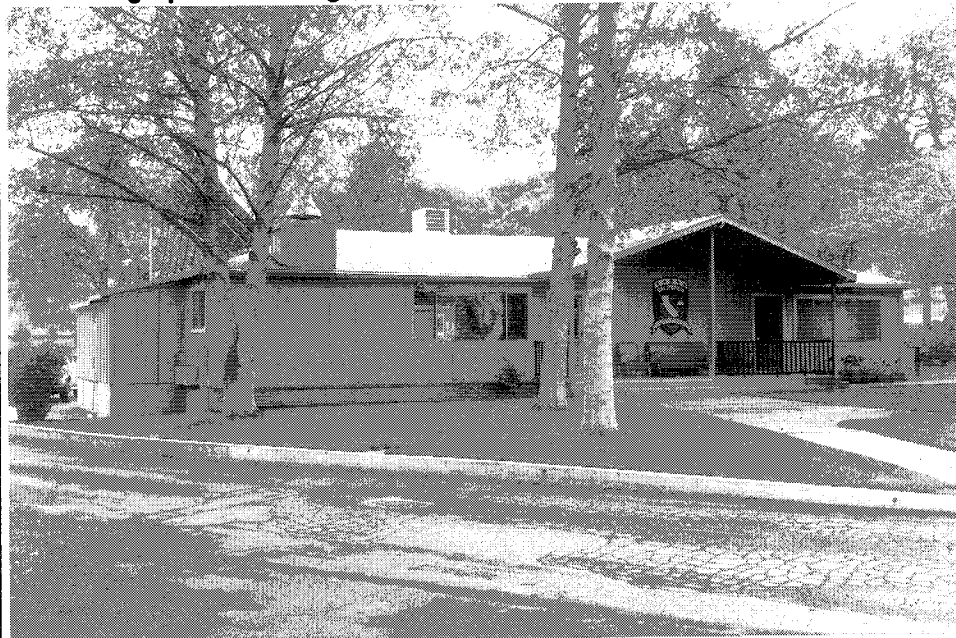
West (front) elevation of the combination barracks.

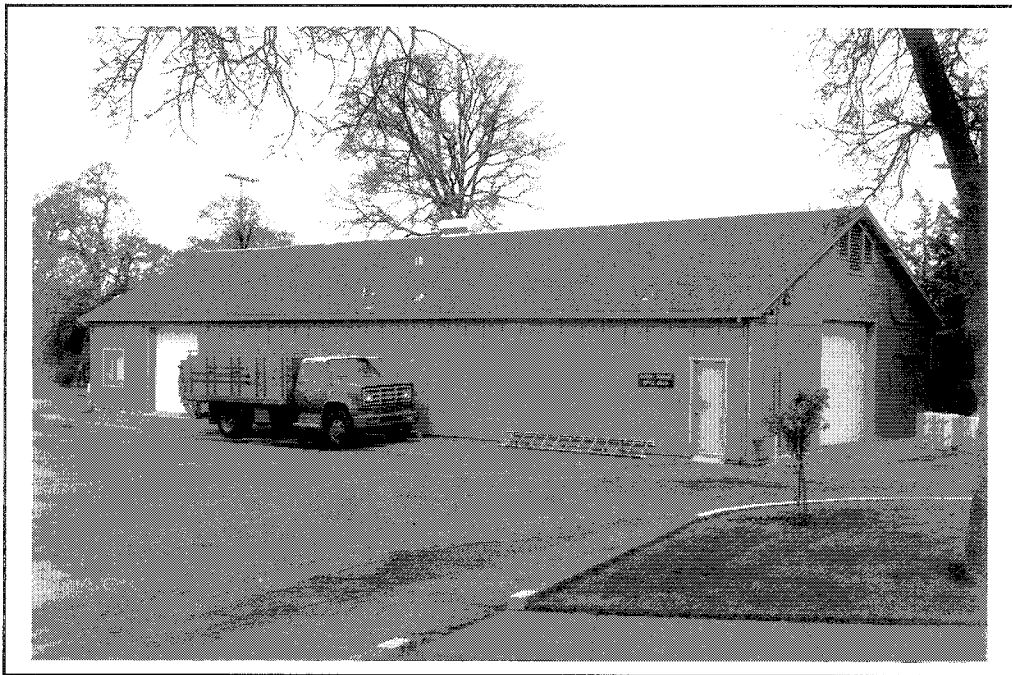
South and east elevations of the warehouse.
